Update “With-Site-Visit” Reserve Study

Meadowcreek II Owners Association Bishop, CA

Report #: 30181-0
For Period Beginning: January 1, 2017
Ending: December 31, 2017

Date Prepared: July 26, 2016

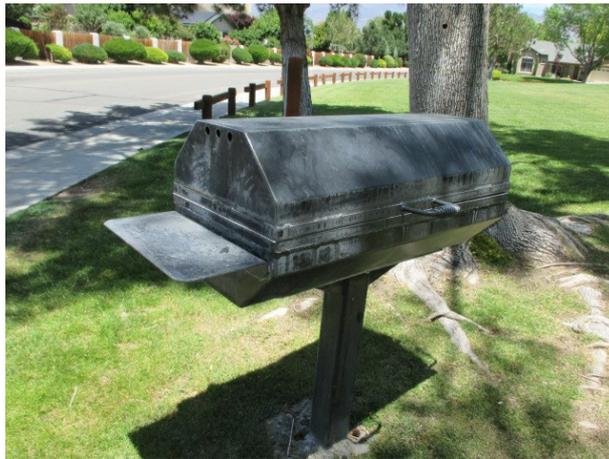
Comp #: 407 BBQ - Replace

Evaluation: Bbq grill appears to be a custom designed steel bbq grounded in concrete. Functional however, some surface wear and fading observed along with minor corrosion. Informed the bbq grill receives minimal to moderate overall use. As routine maintenance, we suggest cleaning and painting of the bbq grill to help maintain overall functionality and possibly extend the useful life.

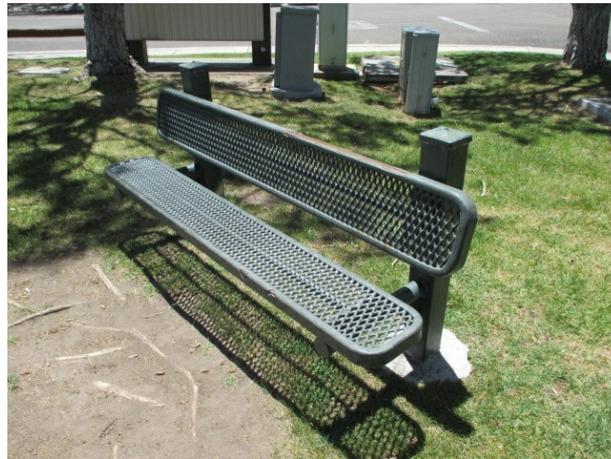
Comp #: 408 Picnic Table/Benches - Replace

Evaluation: The picnic table and benches are vinyl coated and grounded in concrete. Surface wear and fading along with chipped surfaces noted. Informed the picnic table and bench receives minimal to moderate overall use. Life expectancy of picnic tables, benches and other outdoor furnishings can vary greatly depending on level of exposure to the elements, preventive maintenance, quality of material and aesthetic standards of the association. In our experience, it is prudent to plan for replacement of all items together to preserve a coordinated appearance. As routine maintenance, we suggest cleaning and painting of the picnic table and bench to help maintain overall functionality and possibly extend the useful life.

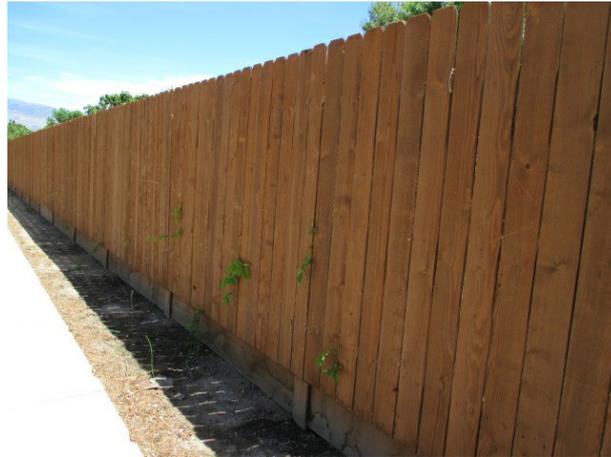
Comp #: 505 Choctaw Wood Fence - Replace

Evaluation: Fence is functional and upright however, isolated boards show minor damage and cracking. As routine maintenance, inspect regularly for any damage, repair as needed and avoid contact with ground and surrounding vegetation wherever possible. Regular cycles of uniform, professional sealing/painting will help to maintain appearance and maximize life. Plan to replace at roughly the time frame below with funding included here for similar wood replacement.

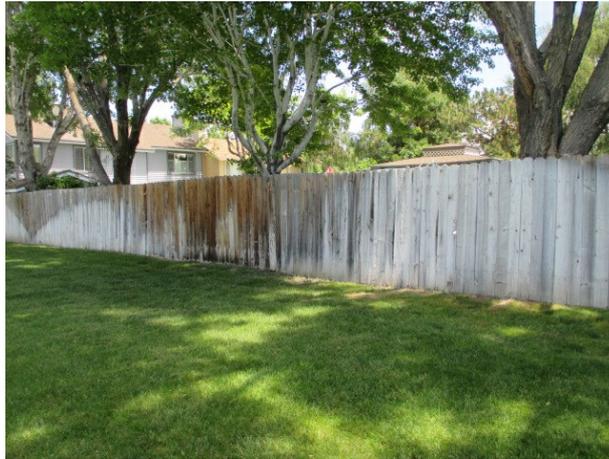
Comp #: 506 Park Common Fence - Replace (Share)

Evaluation: This is the wood fencing at the park area which borders the residential units, and is a shared responsibility with the neighboring residential units. Fence appears to be in fair to aging condition. Isolated boards show minor damaged. As routine maintenance, inspect regularly for any damage, repair as needed and avoid contact with ground and surrounding vegetation wherever possible. Regular cycles of uniform, professional sealing/painting will help to maintain appearance and maximize life. Plan to replace at roughly the time frame below with funding included here for similar wood replacement.

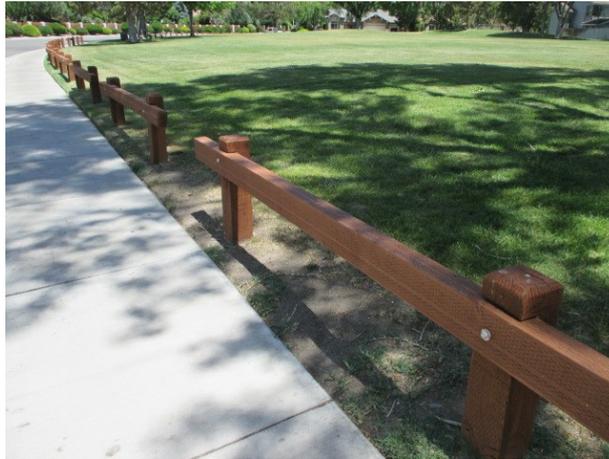
Comp #: 507 Wood Barricade Fence - Replace Quantity: Approx 700 LF, (47) Sect.

Evaluation: This is the barricade split-rail wood fence constructed of pressure treated posts. Functional at this time however, isolated fencing shows leaning and minor damage at the base. No major damage observed. As routine maintenance, inspect regularly for any damage, repair as needed and avoid contact with ground and surrounding vegetation wherever possible. Regular cycles of uniform, professional sealing/painting will help to maintain appearance and maximize life. Plan to replace at roughly the time frame below with funding included here for similar wood replacement.

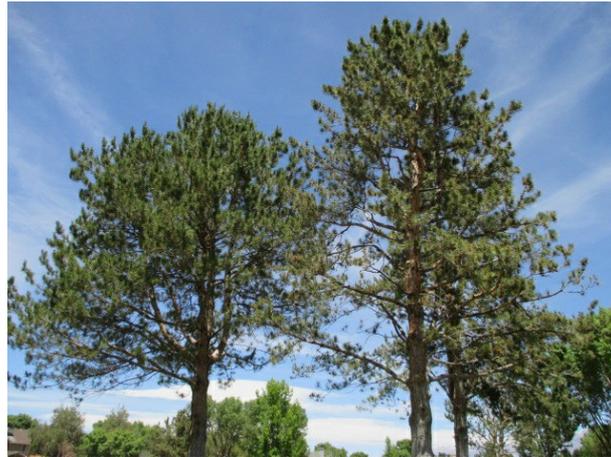
Evaluation: This component may be utilized for larger tree removal/trimming projects which do not occur on an annual basis. If the community has not already done so, consult with a qualified arborist for a long term plan for the care and management of the trees within the community, balancing aesthetics with protection of association assets. Reserve funding recommend at level indicated below for periodic, larger tree removal/trimming needs.

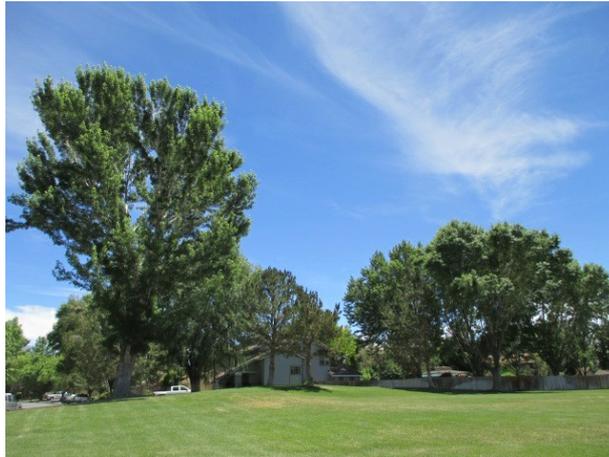
Evaluation: Although typically funded as ongoing maintenance item, this component may be utilized for setting aside funds for larger expenses that do not occur on an annual basis, such as large scale plantings, resodding lawn areas, bark/mulch replenishment, etc. Adjust as conditions, actual expense patterns dictate within future Reserve study updates. If large-scale renovation projects become a part of the agenda, we recommend consulting with the landscape vendor to establish a viable renovation plan that fits the Association's desired aesthetics.

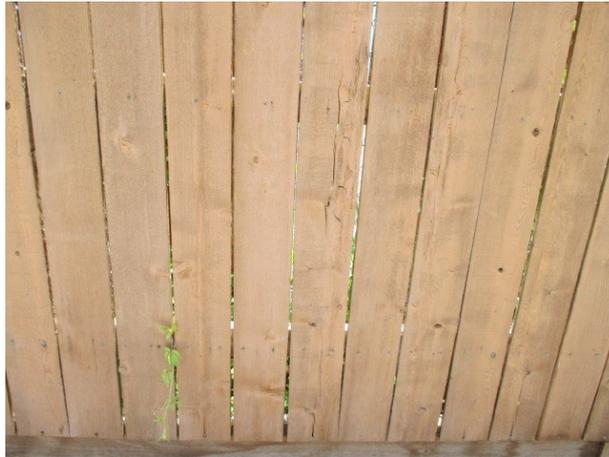
Evaluation: Fence stain appears to show signs of fading and overall surface wear. Regular uniform, professional paint or sealer applications are recommended for appearance, protection of wood and maximum design life. Repair as needed and clean prior to application. Plan for regular applications as shown below. Repair/paint should be coordinated with eventual fence replacement. Wood surfaces will need to be stained or painted in this environment every 5-6 years to protect against wood rot and natural deterioration.

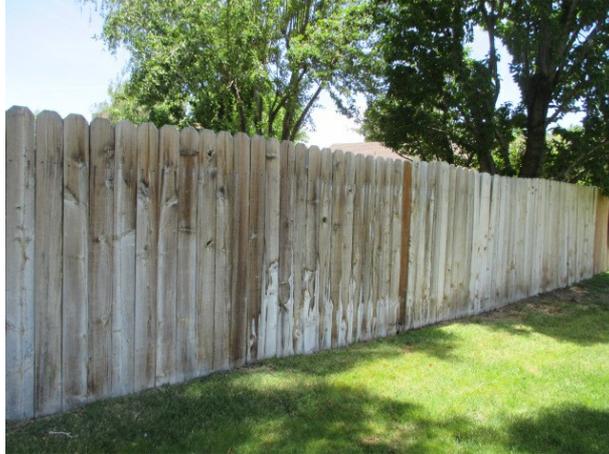
Evaluation: Fence surfaces are faded overall. Regular uniform, professional paint or sealer applications are recommended for appearance, protection of wood and maximum design life. Repair as needed and clean prior to application. Plan for regular applications as shown below. Repair/paint should be coordinated with eventual fence replacement. Wood surfaces will need to be stained or painted in this environment every 5-6 years to protect against wood rot and natural deterioration.

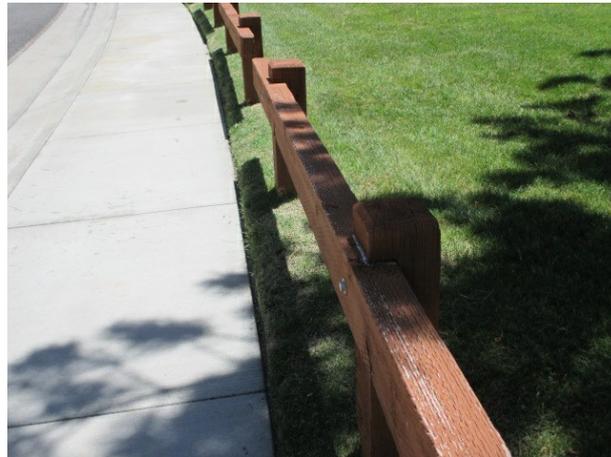
Funded?: Yes.
 History:
 Location: Perimeter of park area
 Evaluation: The barricade split-rail wood fence surfaces are stained. General surface wear and signs of fading noted. Wood surfaces will need to be stained or painted in this environment every 5-6 years to protect against wood rot and natural deterioration.

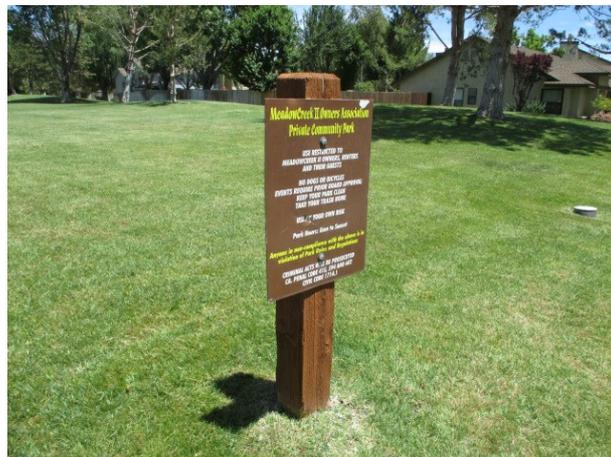
Comp #: 1402 Park Signs - Replace **Quantity:** (4) Signs, (4) Posts

Funded?: Yes.
 History: Prior Reserve Study indicates last replaced in 2009.
 Location: At park area
 Evaluation: These are the custom Association park signs attached to pressure treated posts. Functional and legible. Isolated signage shows some minor damage. No signs of major abuse or vandalism. This component funds for periodic replacement of the park signage including the posts at the interval below.

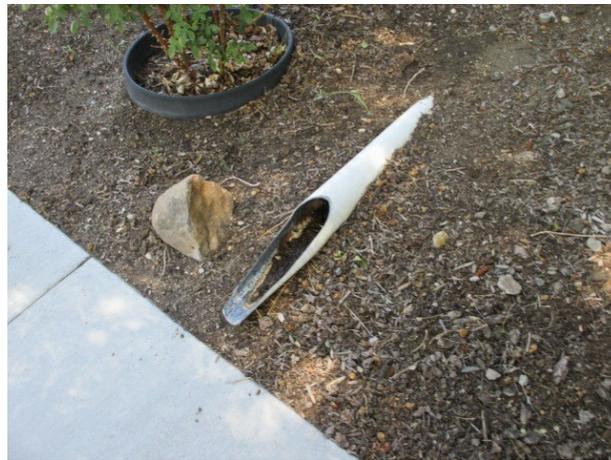
Comp #: 1834 Drainage System - Repair/Replace Quantity: Common Area Drainage

Evaluation: Informed by the client there are various french drainage systems throughout the property. Analysis of the drainage system is beyond the scope of our services. The french drainage system is assumed to have been properly designed with adequate provisions for community drainage needs. We recommend periodic inspections and consultation with a licensed professional to help ensure the drainage systems are intact and functioning properly without any obstruction to drainage from tree roots, sediment, etc. If patterns of significant repair emerge, funding may be incorporated into future Reserve study updates. At this time, there is no basis for Reserve funding.
